Real Estate Inspection Report

Prepared Exclusively for: Eddie Haskell
Inspection Performed on
01/15/24

3430 Canyon Oaks Ct Santa Cruz, CA

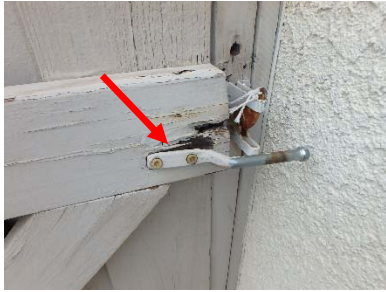
Example – Loose gate Latch Arm

[MRR] The right-side gate latch arm is loose and the gate drags the ground. Fencing at several areas around the rear yard is loose and deteriorated. Budget for repairs and future maintenance. Fence Contractor.

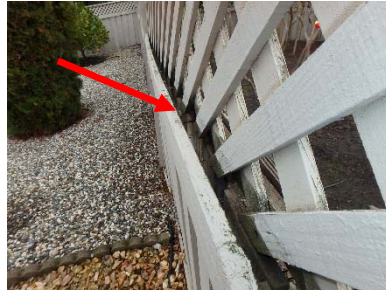
Example – Loose Fencing Slats

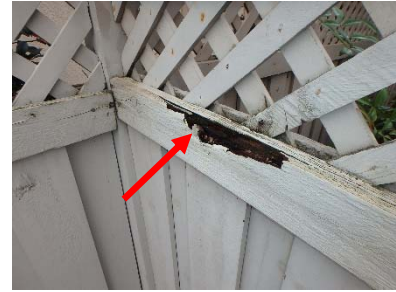
Example – Deteriorated Fencing

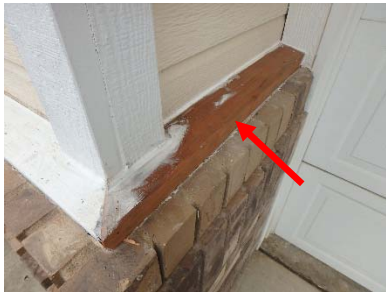
Trim at Garage

[MRR] Unfinished repairs were observed at exterior trim at the front of the garage and roof sheathing area at the rear of the home. It looks like all that is left is painting. Refer to seller. If someone deems these repairs to be complete, budget to have these areas painted. Painting Contractor. There is a piece of weather-stripping installed at the front door, which prevents the front door from being easily opened/closed. You may wish to have a competent contractor provide an alternative means to weather-strip this door, so it can be easily operated.

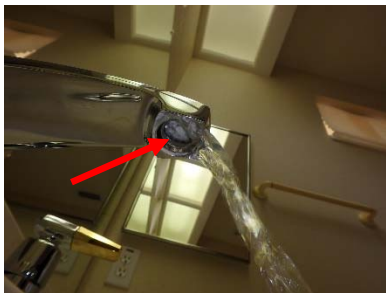
Example – Missing Aerator

[NOTE] Both aerators at master bathroom sink faucets are missing. This is a waste of water. The sink stopper rod at the left side master bathroom sink has a deteriorated end, which no longer will engage the sink stopper. Aerators and stopper rods can be found at home improvement stores and are easy to install. While still functional, the water heater is at the end of its normal service life (10 years). It is 11 years old. Budget for a replacement.

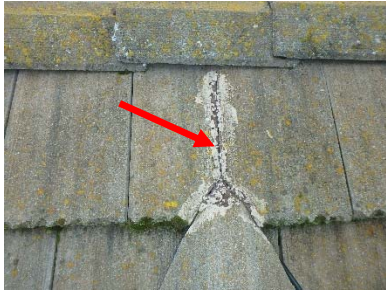
Cracked Adhesive

[MRR] Inspection of the roof covering revealed the following conditions: There are two tiles which were adhered together at the top left section of the roof. One tile should have been trimmed to fit around the top of the ridge and a cut tile should have been installed at one end of this row/course. This was probably a result of poor planning by the roof installer. The sealant used to join these tiles together is cracked. Sealant should not be used here, as it is prone to crack when exposed to sunlight. A piece of malleable flashing should correct this. Excessive moss growth was observed at several areas. Debris and moss growth observed in roof valleys, atop the roof covering and in the gutters. A section at the rear of the roof, where the wall extends out, is difficult to make weathertight. Care and attention to detail is required here to prevent water from getting beneath the roofing paper. Presumably, this is the reason the roof sheathing was replaced in this area. While a new piece of roofing paper was installed above the repair area, there is still deteriorated roofing paper above this area, where water can get to the roof sheathing. These conditions can result in a roof leak. Roofing Contractor.

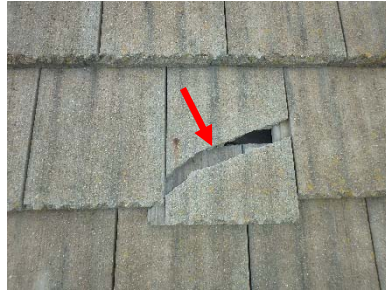
Damaged Tile

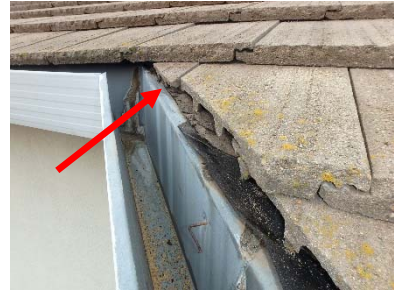
Deteriorated Roofing Paper

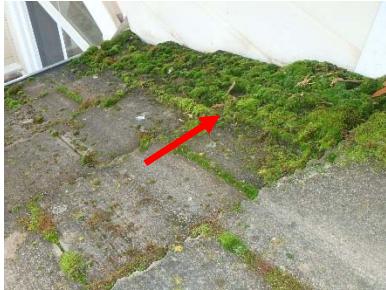
Example – Moss Growth

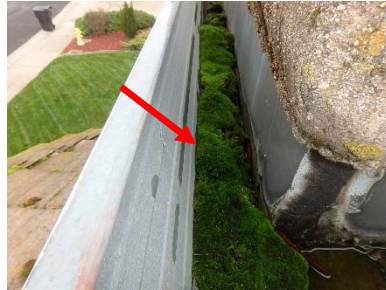
Example – Debris in Gutter

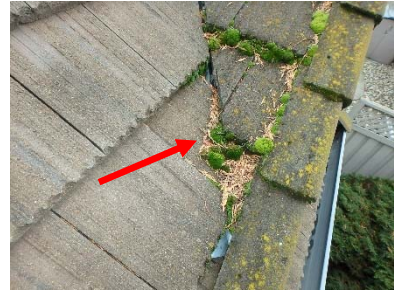
Example – Debris in Valley

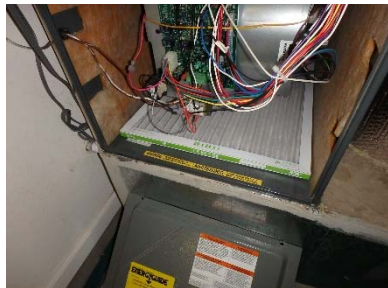
Air Filter Inside Furnace Cabinet

[MRR] The air filter is located at the base of the furnace cabinet. The furnace is not designed to house the air filter here, as it is loose-fitting and will not filter all the air. Presumably, the air filter was once installed at the return air grill in the hallway. You can see that a different return air grill was installed, one without an openable cover. Presumably, the person who had this done, wanted to access the air filter from a location that didn't require the use of a ladder. If you'd like to keep the air filter located inside the furnace cabinet, have an HVAC contractor devise a means to keep it securely in place, so all the air gets filtered and prevents the evaporator coil and fan motor from getting dirty. Or, you can have an HVAC contractor install a return air grill in the hallway ceiling, which will accommodate an air filter.

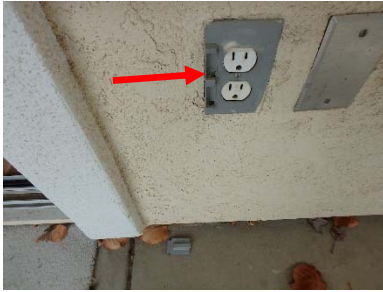
Rear of Home

[MRR] The weather tight outlet cover at the rear exterior of the home is damaged. Install a new cover. 2 light switches which control the kitchen ceiling fluorescent lights are loose in their housings. Replace the switches. The fan speed control pull chain for the ceiling fan in the family room cannot be easily accessed. The pull chain doesn't extend below the light housing. Presumably, the wrong light kit was installed. You wouldn't think that the pull chain would drape over the light housing, but that's the only way it would work. Electrical Contractor.

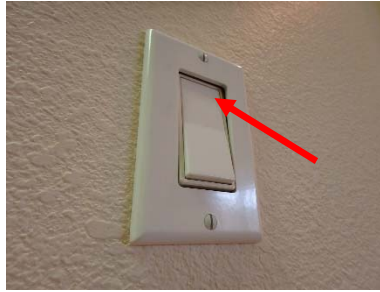
Example – One Kitchen Light Switch

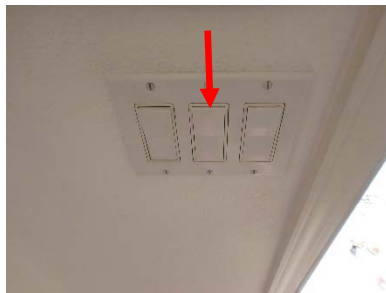
At Rear Door

[NOTE] Unknown switch purpose detected at the rear door. Middle switch. Unused circuit at the exterior? Refer to seller.

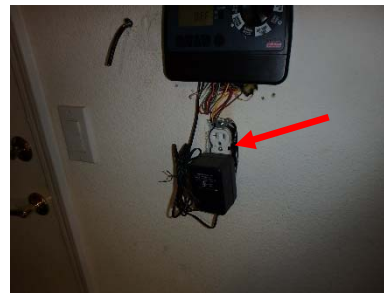
Right Side Garage Wall

[HSC] The outlet at the right-side garage wall, beneath the irrigation timer is not GFCI protected. Presumably, a single pole outlet was once installed here and those are not required to be GFCI protected, if only the irrigation timer can be plugged in here. Install a single pole outlet and cover plate OR a GFCI outlet and cover plate. Electrical Contractor.

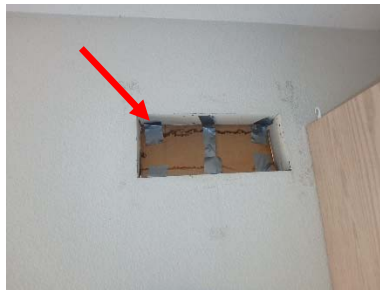
Right Side Wall in Garage

[NOTE] Remove the cardboard panels at the ventilation openings in the garage. Fuel burning appliances in the garage require fresh air.

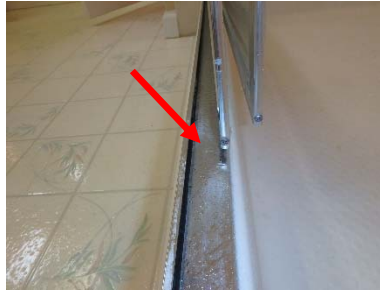
Master Bathroom

[HSC] The shower doors in the master bathroom do not have a door guide installed. This can allow the shower doors to swing inward and possibly fall out of the track. Competent Contractor.

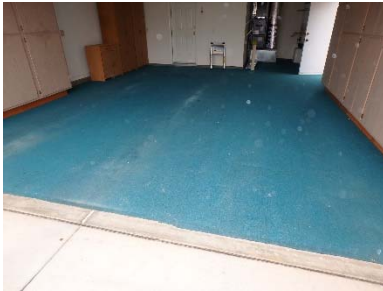
Carpeting on Garage Floor

[HSC] Carpeting (combustible floor covering) is not permitted to be installed on a garage floor. The concern is the increased risk of a fire, due to vehicles being parked on it. You may wish to obtain a bid to have it removed. Competent Contractor.

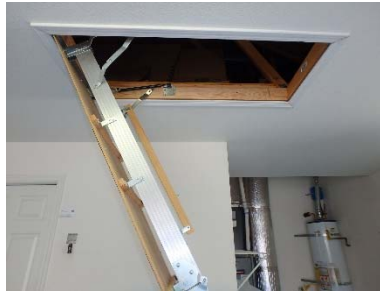
Attic Ladder

[HSC] An attic ladder is installed at the garage ceiling. This is not a fire-rated assembly. Attic accesses in the ceiling of a garage are required to be fire-rated (1 3/8" thick solid door/approved access cover) and self-closing. The purpose of a fire-rated, self-closing access door is to prevent the passage of smoke/flame into the attic space in the event of a fire in the garage. Competent Contractor.

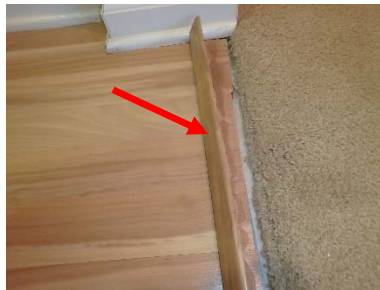
Loose Threshold Piece

[NOTE] The threshold at the flooring between the kitchen and hallway is loose. Have it re-adhered into place.
